Manhole Inspection Summary

Manhole # S37YY_040MH

Insp Date: **12/28/06 12:05 PM**

Location Address: **501 33RD ST**

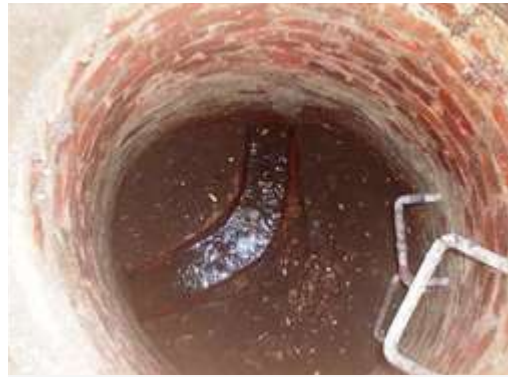
Top View

Barrel infiltration. Evidence of surcharge - Bench debris. Channel debris.

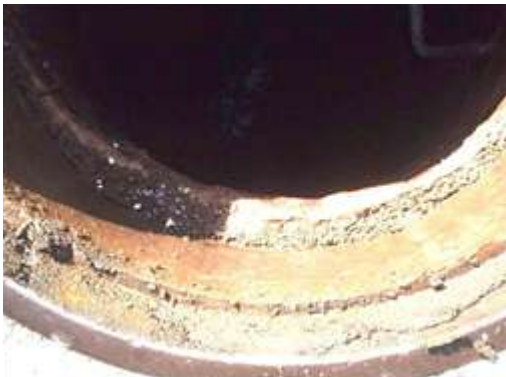
Defect

Frame leaks. Frame offset. Adjustment infiltration.

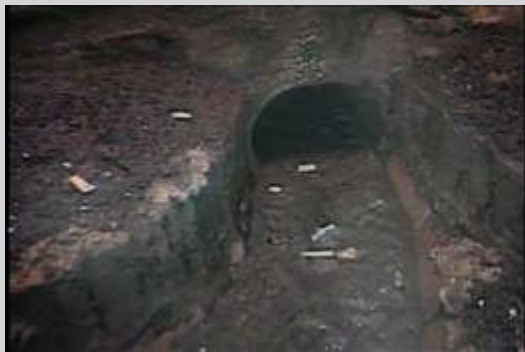
8 in. Circular Gravity Sewer Pipe Out @ 12 O'Clock

Invert Depth: **7.43** (ft.) Flow Characteristics: **Slow**

Deposits: ☐ None ☒ **Mud** ☐ Sludge ☒ **Debris** ☐ Grease

Silt Depth: **1** (in.) Deposits Extent: **Light**

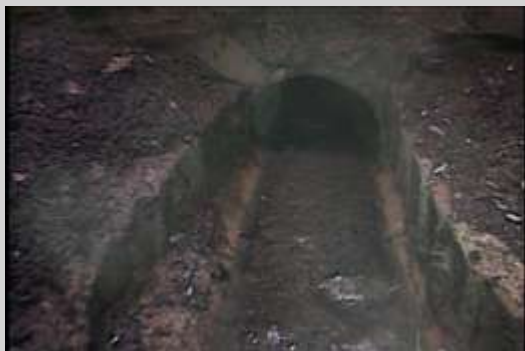
8 in. Circular Gravity Sewer Pipe In @ 8 O'Clock

Invert Depth: **7.30** (ft.) Flow Characteristics: **Slow**

Deposits: ☐ None ☒ **Mud** ☐ Sludge ☒ **Debris** ☐ Grease

Silt Depth: **1** (in.) Deposits Extent: **Light**
